Surfside:

Buildings just don't fail like this!

Department of Regulatory and Economic Resources Sergio T. Ascunce, Deputy Building Official

Champlain Towers South 8777 Collins Ave, Town of Surfside, FL

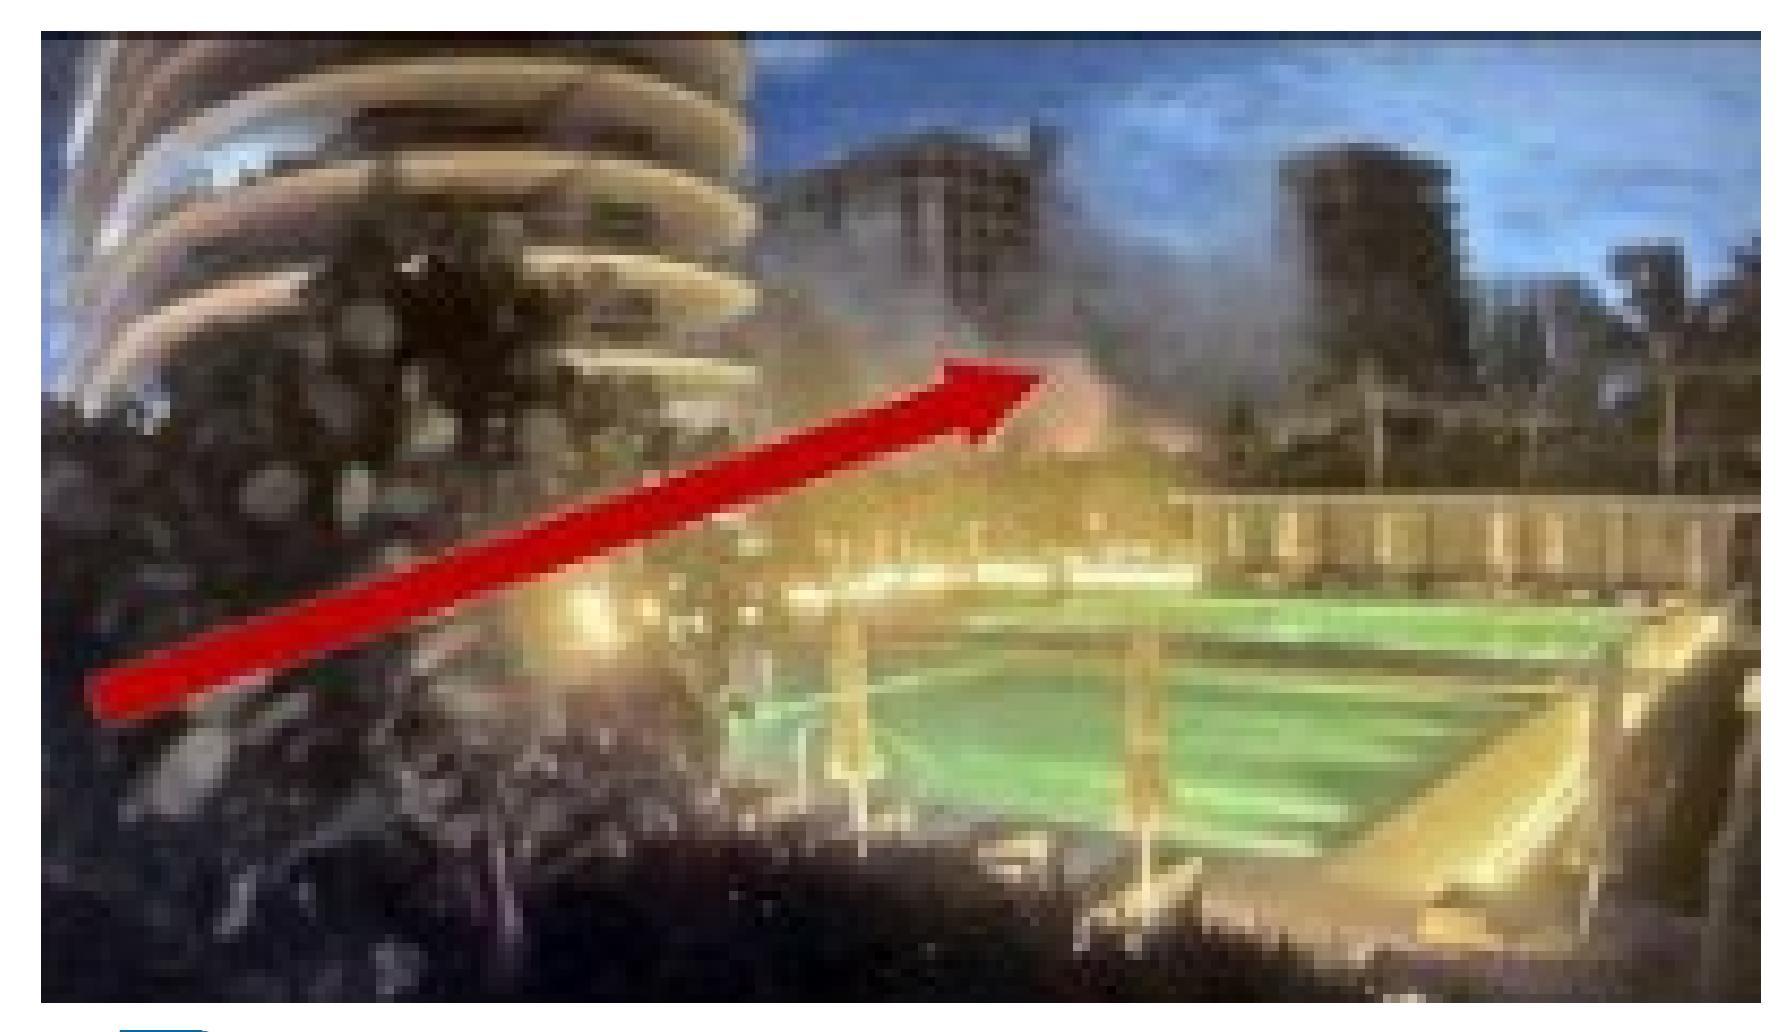
Champlain Towers South Collapse

Collapsed Portion of Building

- The collapse resulted in 98 Fatalities
- Approximately 102 made it out of the building
- A portion of building suffered catastrophic failure
- Lots of speculation about what triggered the collapse, at the time
- To date, reason(s) for the collapse remain unknown
- NIST is still working on forensics

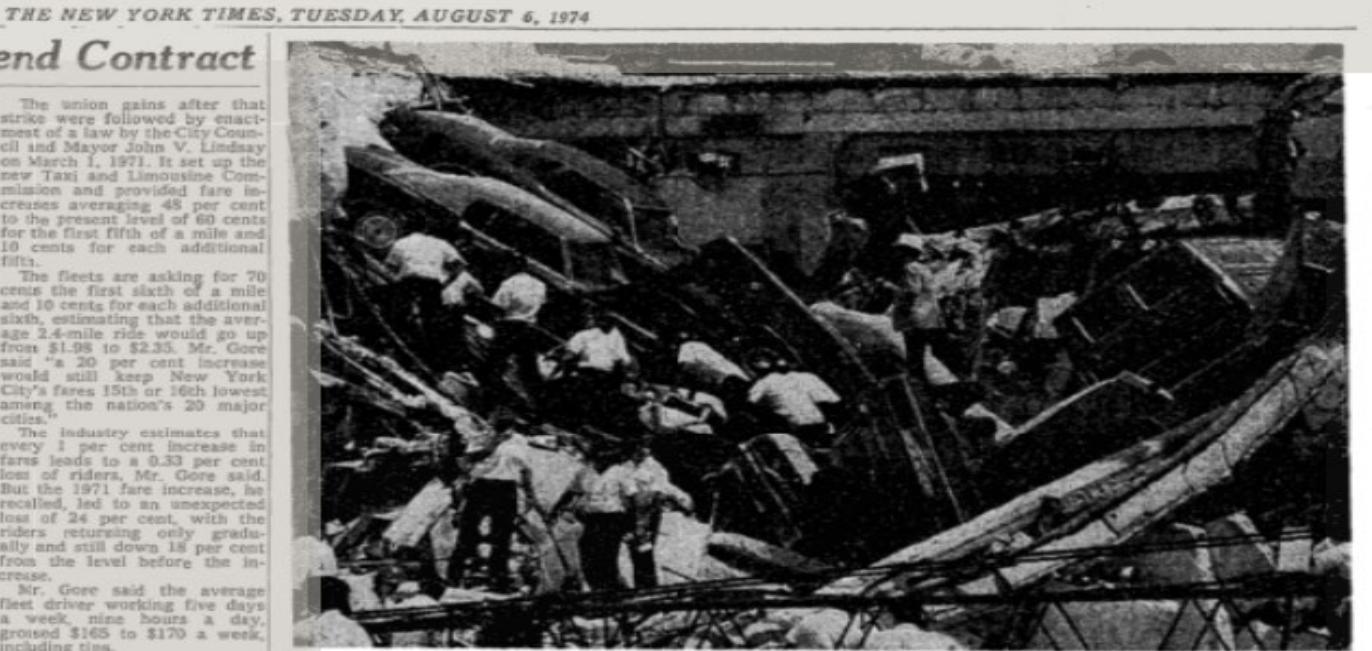
Rescue workers swarming over wrockage of cars that had been parked on roof of Federal office building in Miami

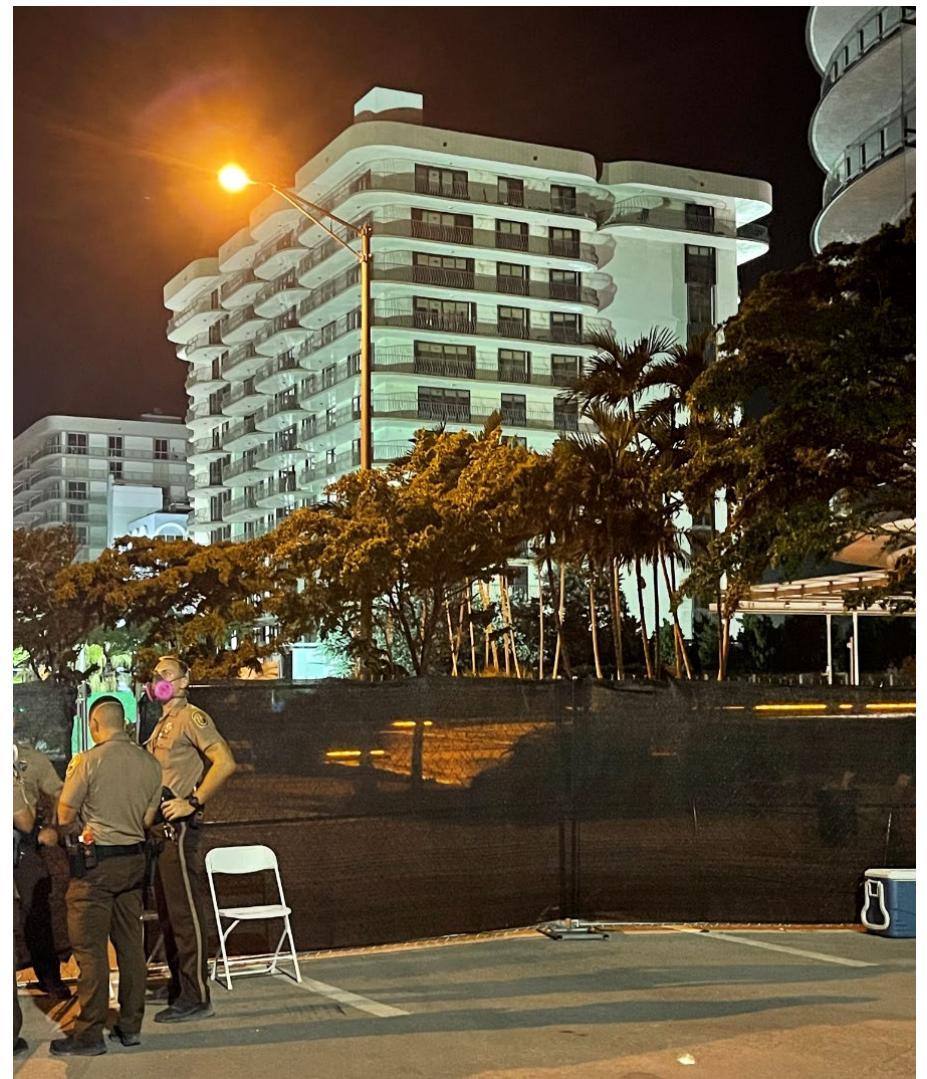
Demolition of Remaining Building

On July 4th, 2021, at 10:30 p.m. the remain building was imploded.
