Post-Fire Restoration of Cross-Laminated Timber (CLT)

Example Solutions for the ATF/FPL Test Structure

Ad Hoc Committee – Tall Wood Buildings
October 9-10, 2018

Presented By: Smartlam - Jim Henjum, PE
Contribution by AWC – Jason Smart, PE

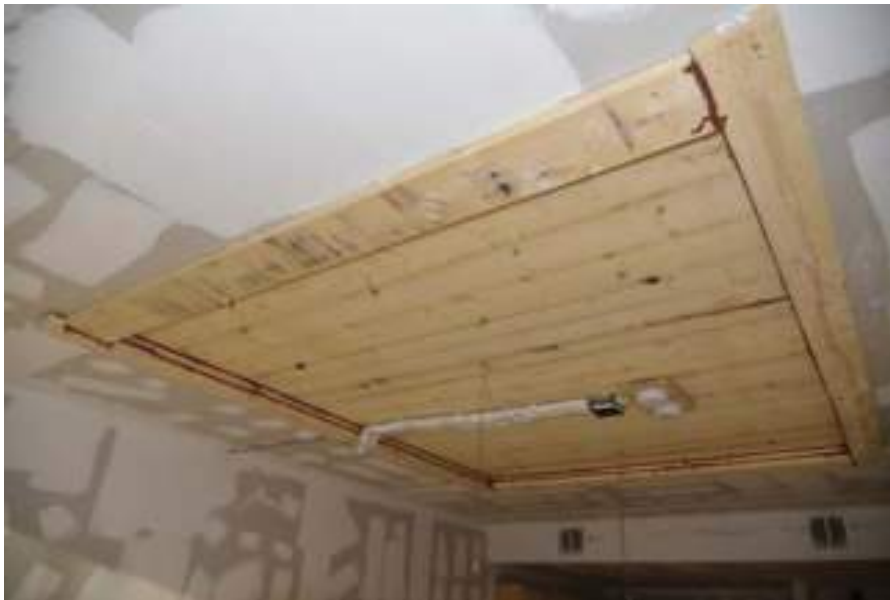
Figure 1: Exposed Ceiling for Test 2

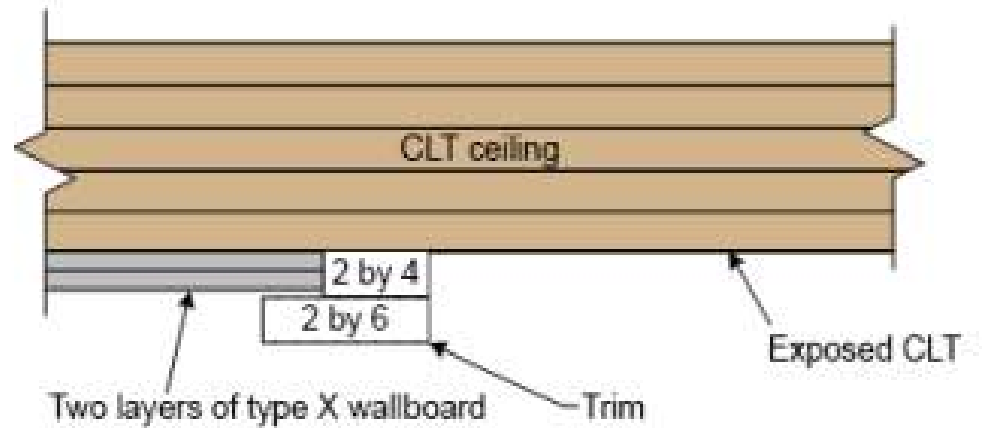
Figure 2: Edge Details of Exposed CLT Ceiling for Test 2

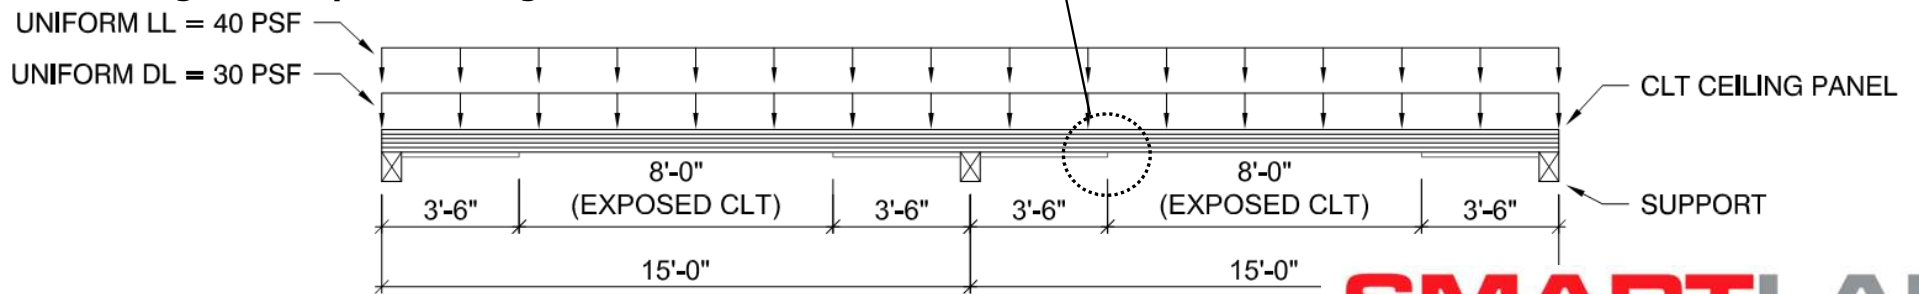
Figure 3: CLT Span and Loading Conditions

- ATS/FPL Span Example – 5ply CLT

Example Calculation:

Effective Span Length = 14'-3"

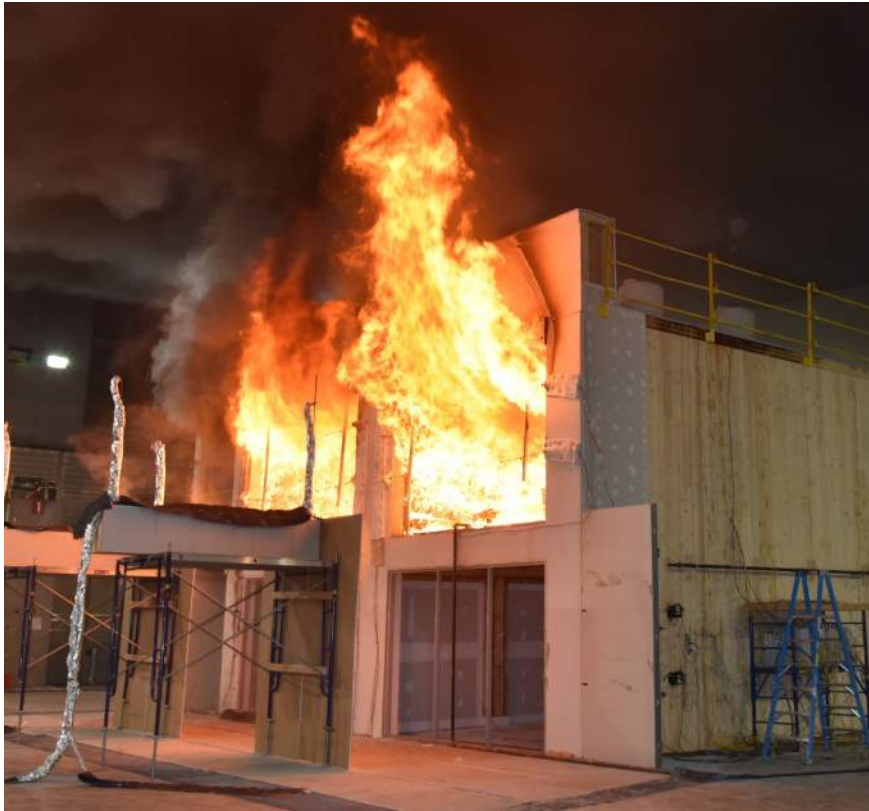
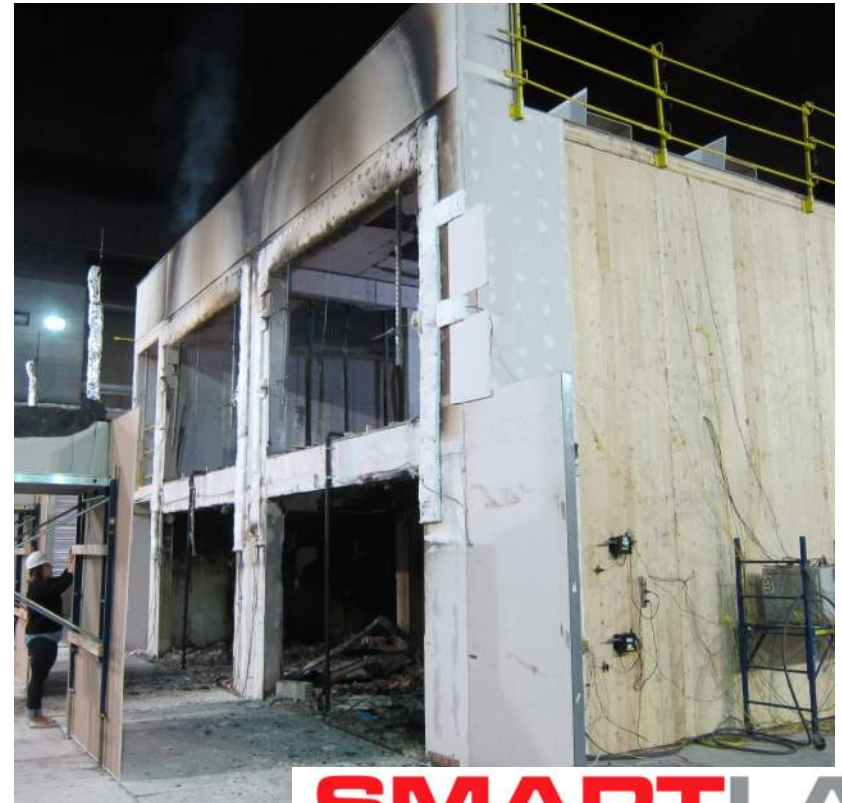
Test Structure: During and After the Fire

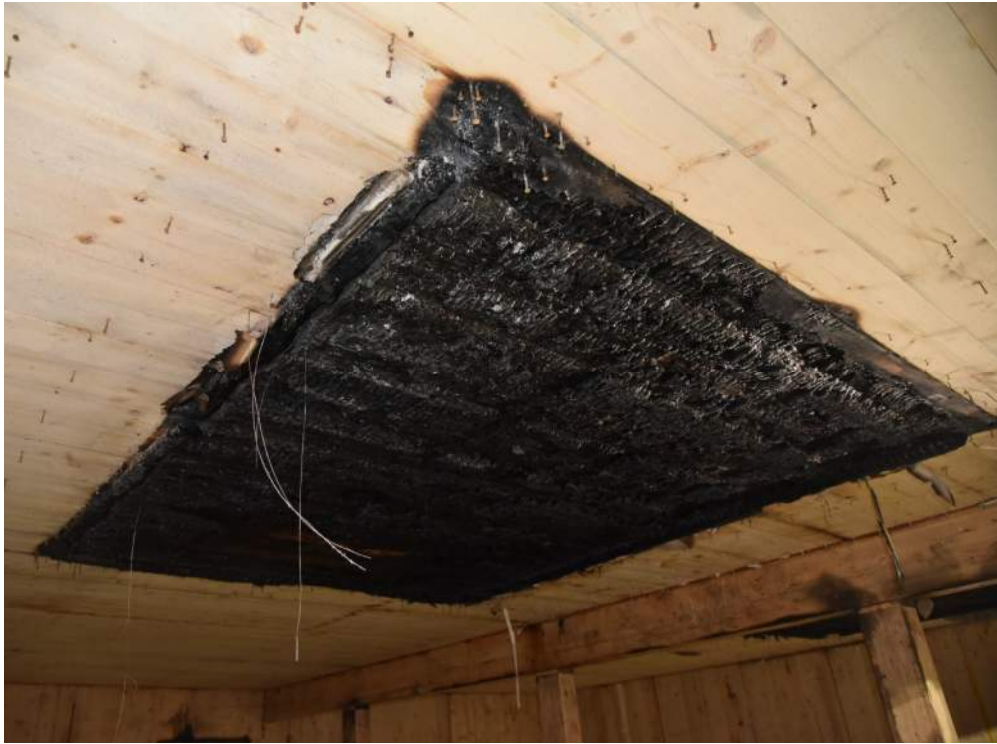
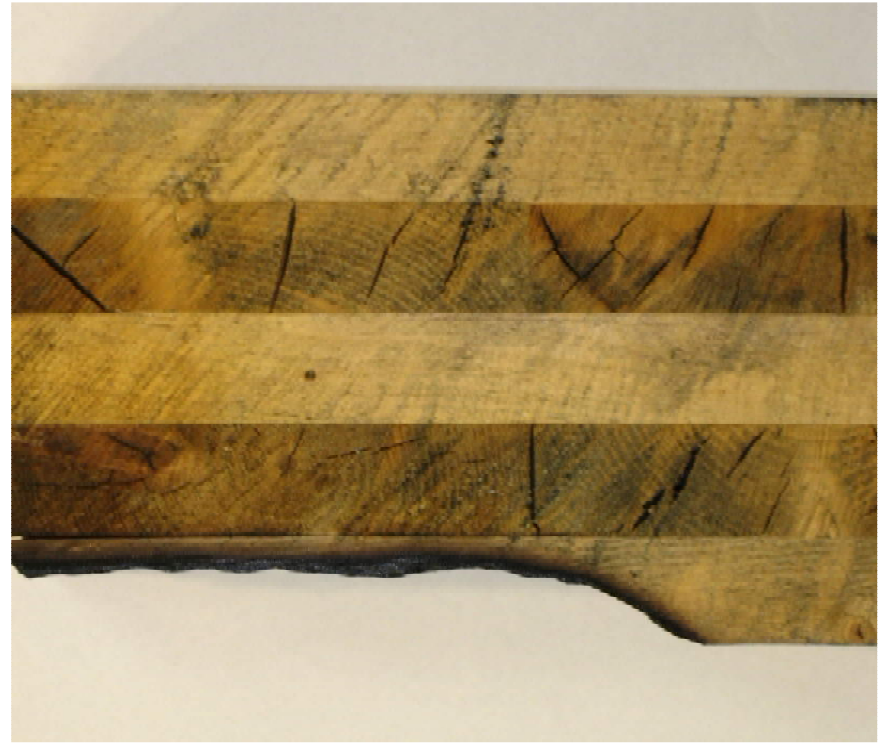
Exposed Portion on Ceiling: After the Fire

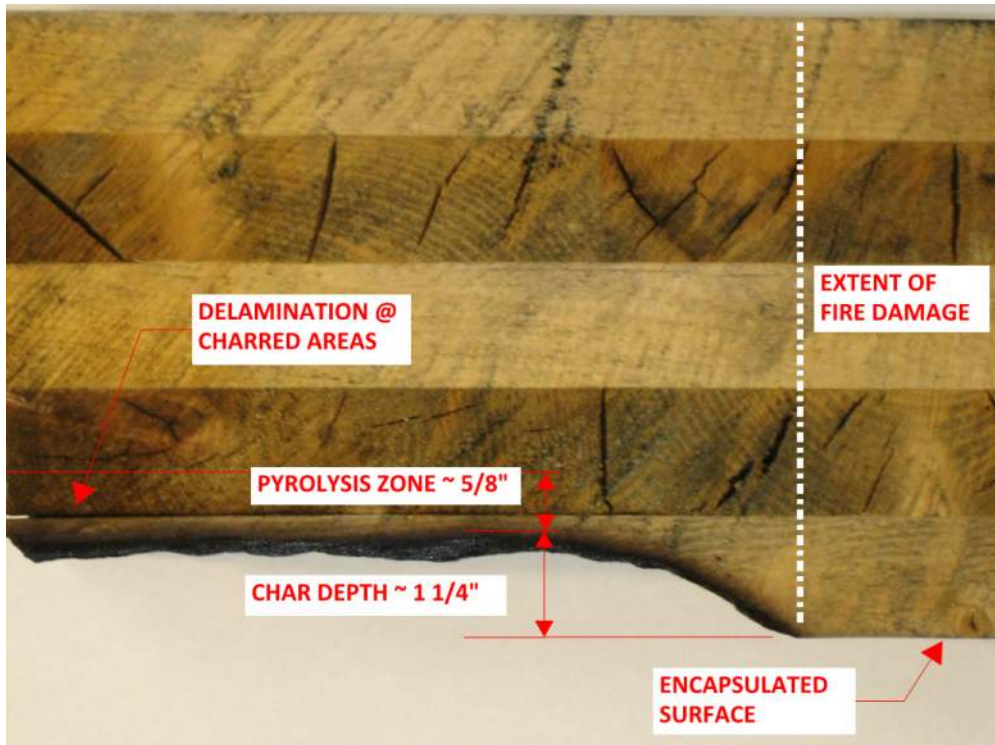
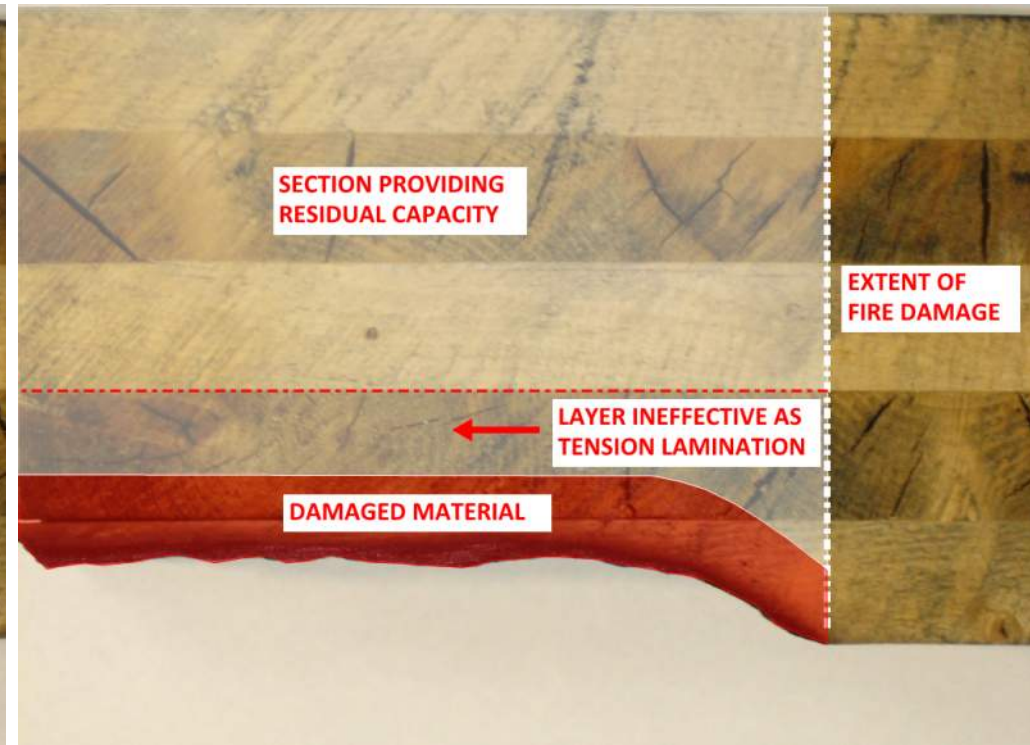
Exposed Portion on Ceiling: After the Fire

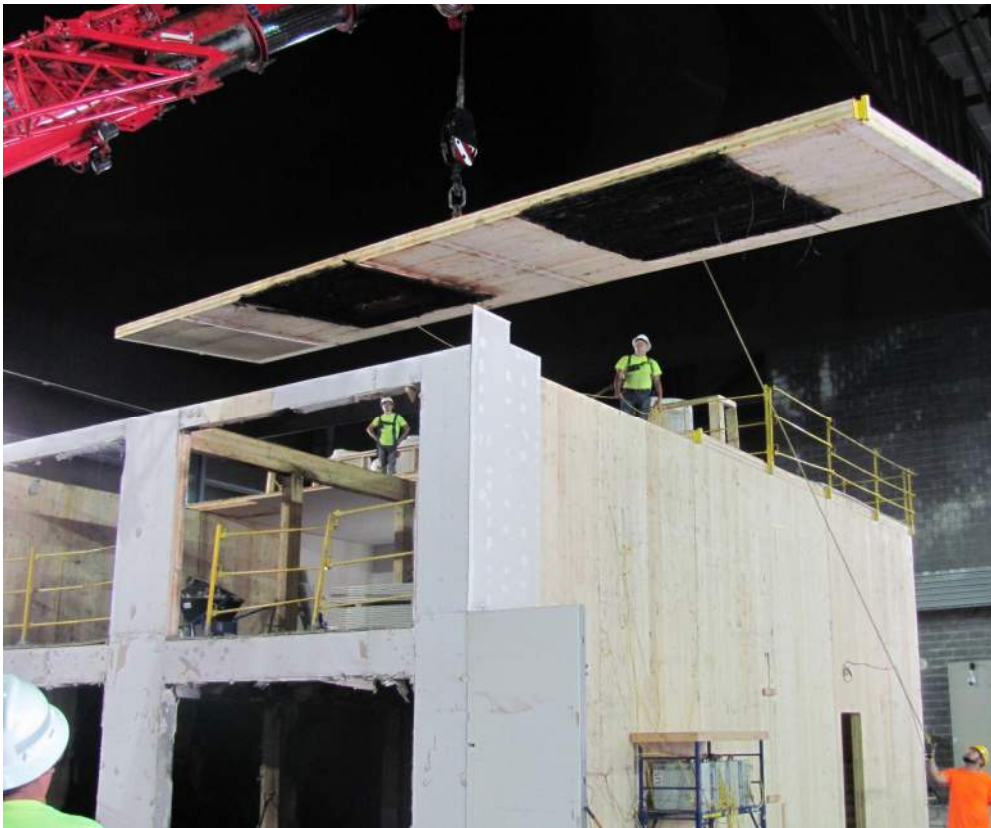
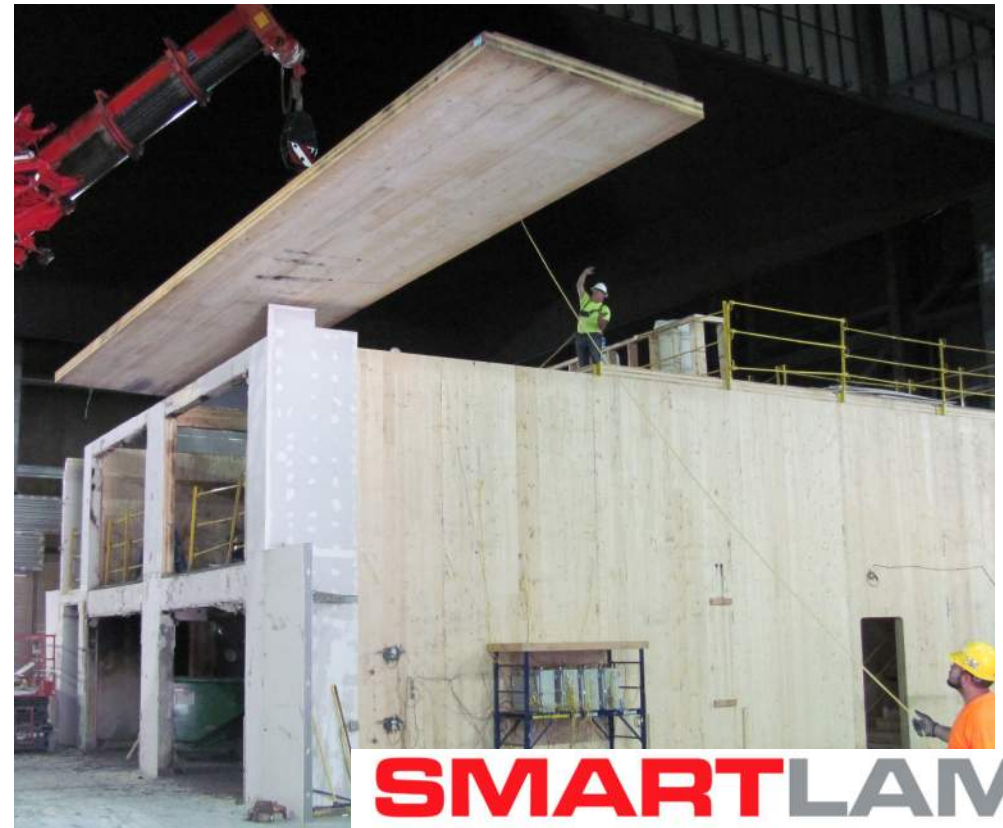
Rehabilitation Option 1:

Removal and replacement of damaged CLT slabs

- Restores Full Capacity of Panel

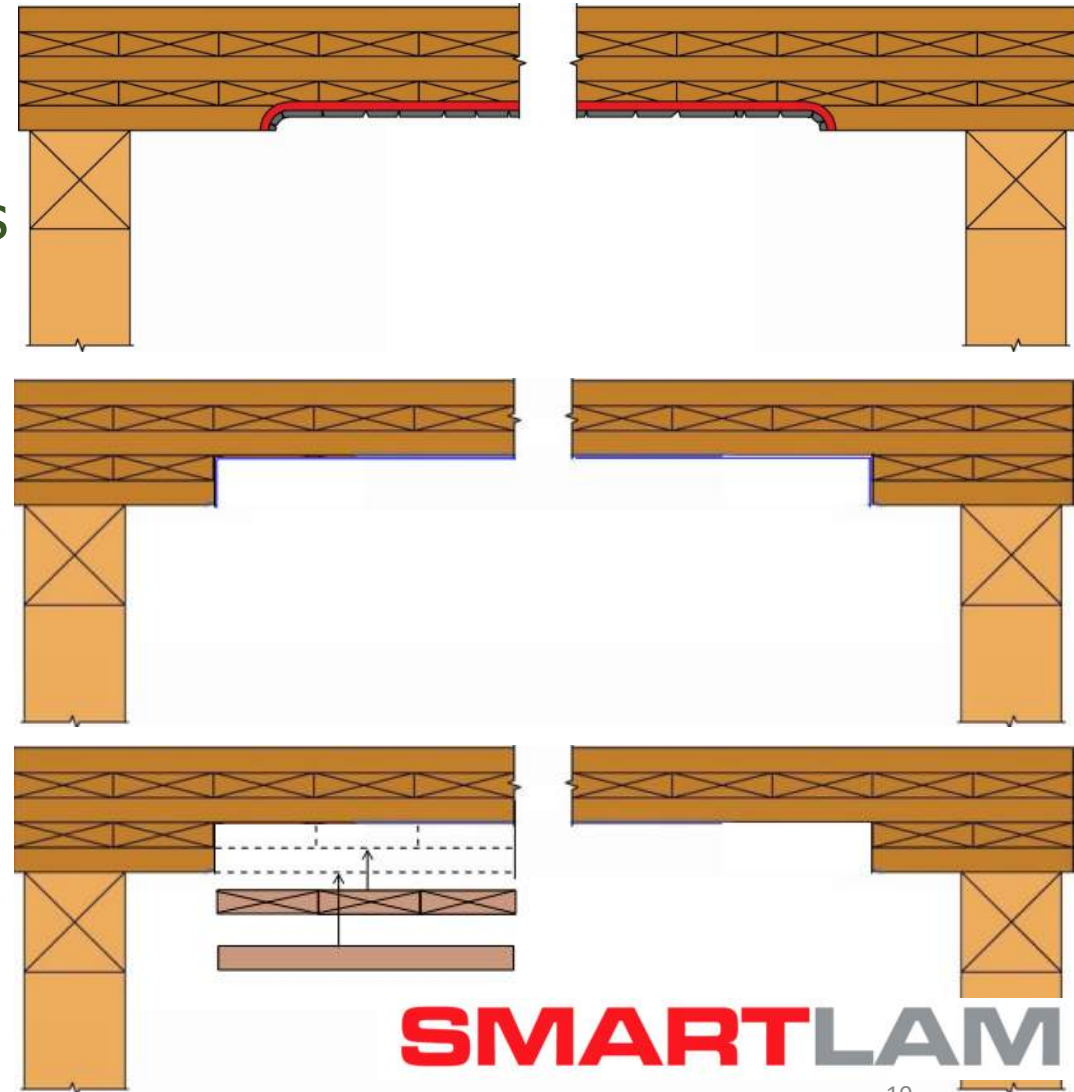
Rehabilitation Option 2:

Analysis to Prove Fire Damaged CLT has Capacity to meet demands of service loads.

- Fire Damage CLT
- Remove and Clean Damage Portion
- Replace with new laminations attached with adhesive. Mechanical Fasten or Clamp. (Reference Option 3)

- Simple
 - Based on Engineering Mechanics
 - Defined Properties in PRG-320 or Manufacturers Product Report.

- Restores Fire Resistance Rating.

- Does not restore full structural capacity of CLT panel

- Maintains exposed CLT

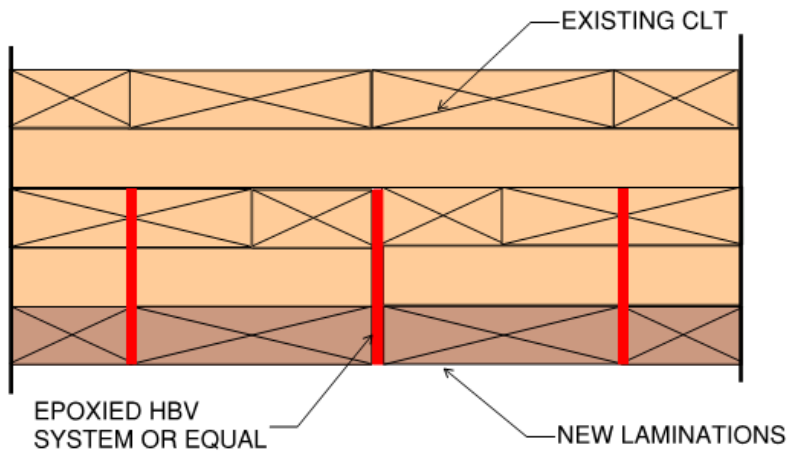
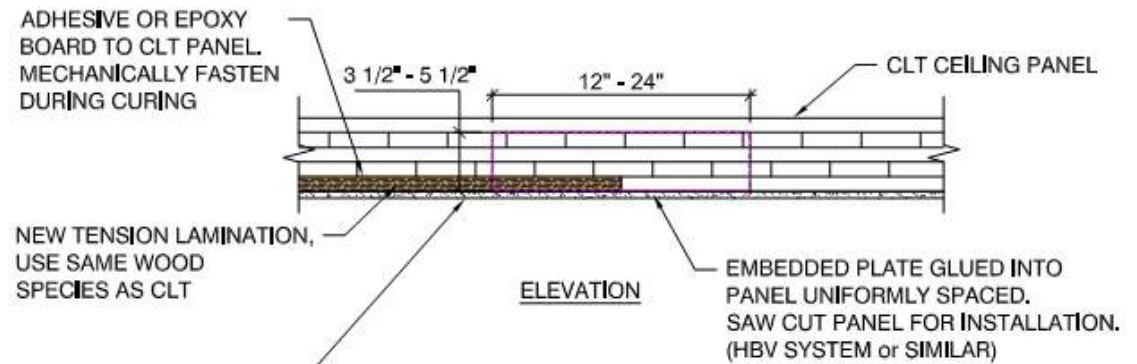
Rehabilitation Option 5: Embedded plate to restore flexural capacity

Similar to Option 4

Timber to Timber Composite
