Surfside:

Buildings just don't fail like this!

Department of Regulatory and Economic Resources Sergio T. Ascunce, Deputy Building Official

Champlain Towers South 8777 Collins Ave, Town of Surfside, FL

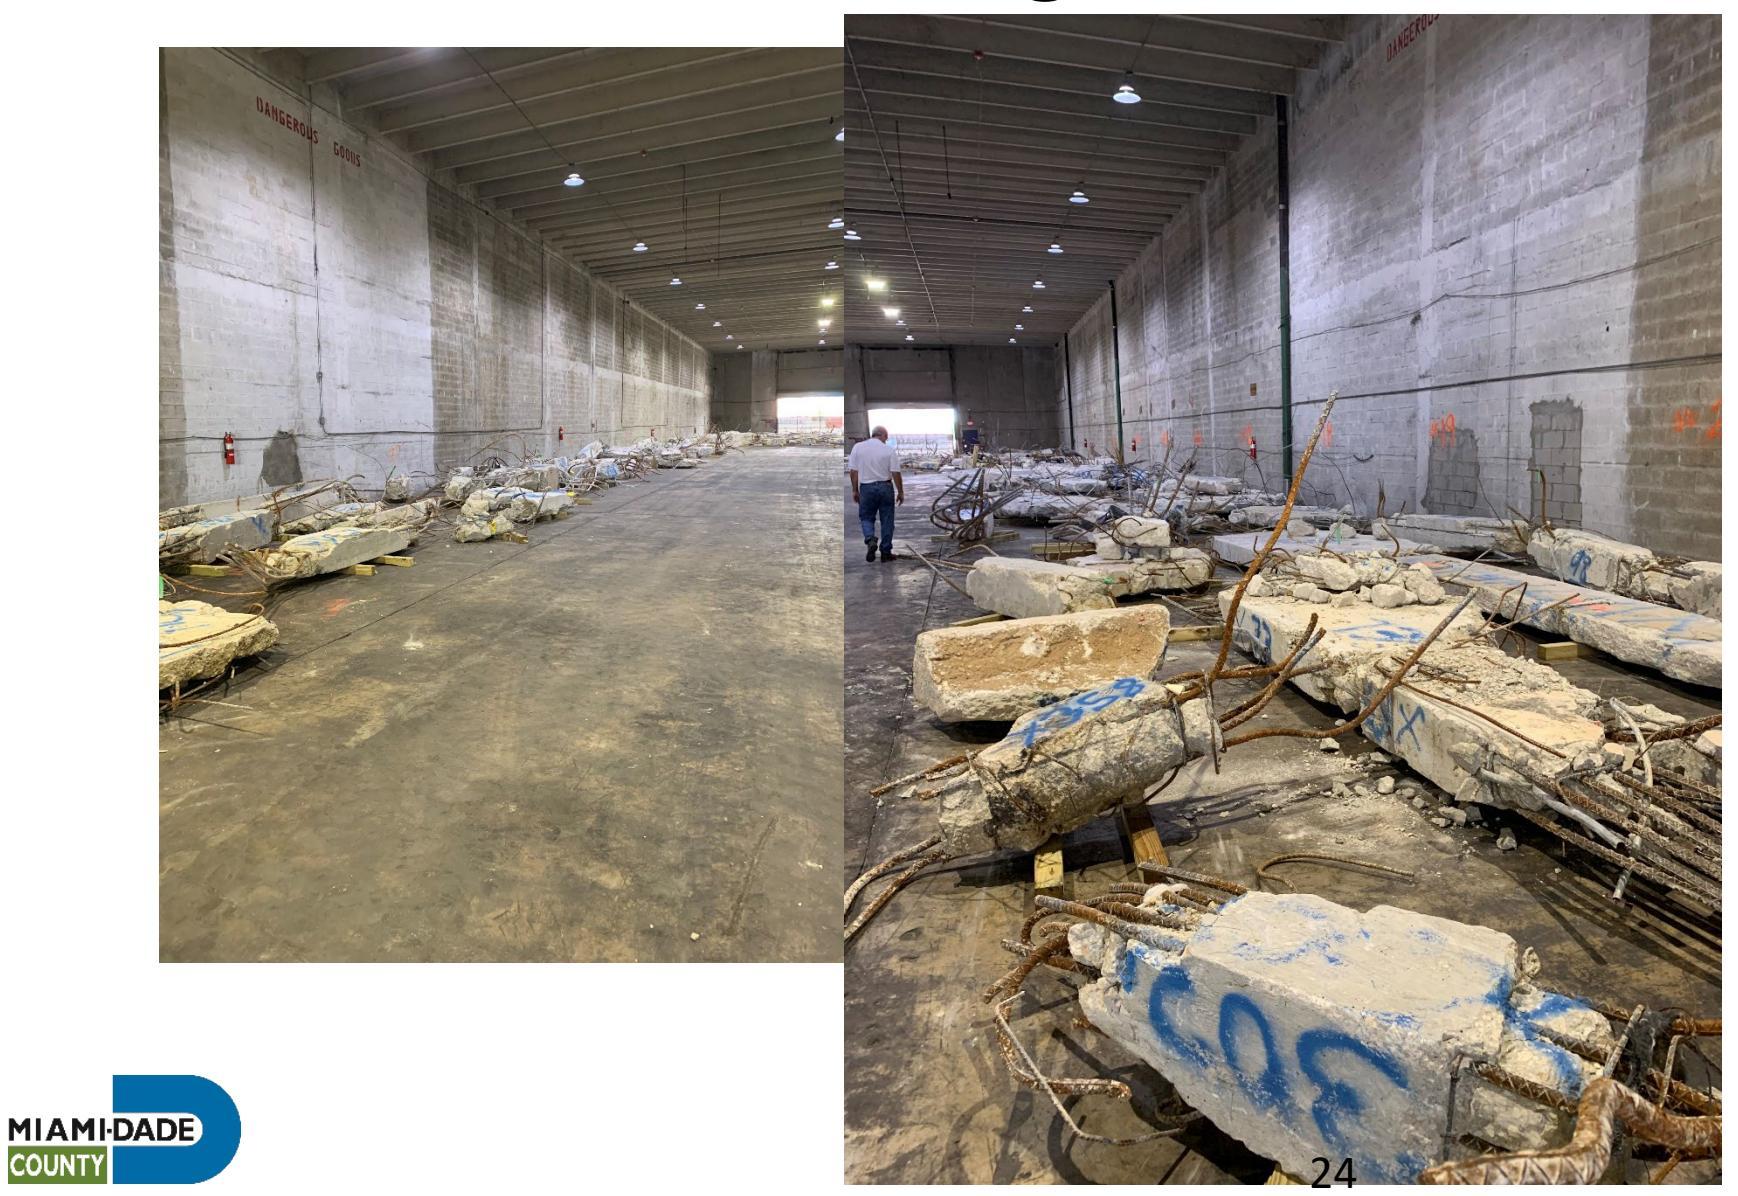
NIST Investigation

- There are lots of speculations and theories as to the cause of the collapse.
- There are many videos on social media that offer analysis and reasons.
- National Institute of Standards & Technology (NIST) is currently working on determining what triggered the collapse but won't have report for some time.
- NIST collected structural samples that are being kept in a warehouse for analysis.
