INSTALLATION

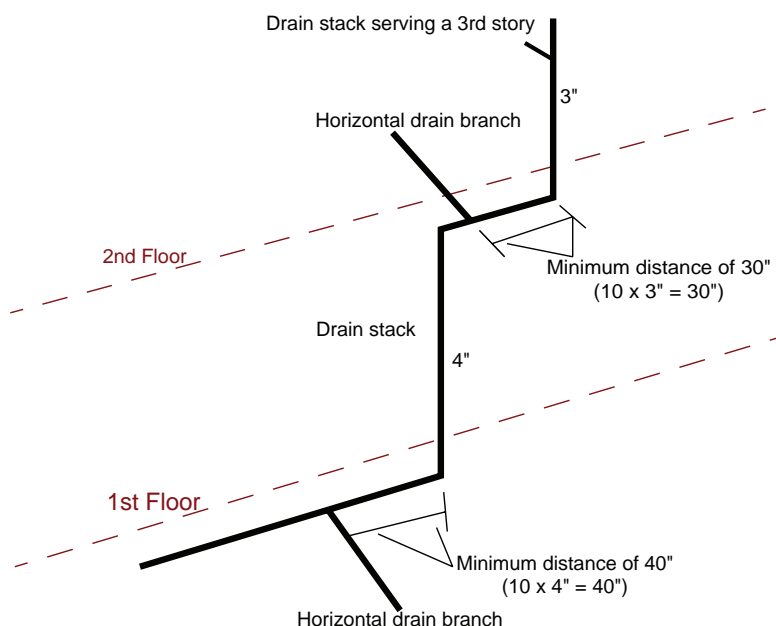
FIGURE 5-2 Connections near stack

Horizontal branches must connect downstream of the base of a stack a minimum of 10 pipe diameters. Basically, multiplying the diameter of the stack by 10 provides the minimum horizontal distance in inches downstream of the stack where a horizontal drain branch may connect, 30 inches for a 3-inch stack, 40 inches for a 4-inch stack, etc. A drain stack is the vertical line of soil or waste piping that extends through not less than one story with or without offsets. The same required distance applies to horizontal connections in a stack offset (Figure 5-2). [\[Ref. IPC 704.1, 704.3 and IRC P3005.4.2, P3005.5\]](#)

The IPC prohibits the connection of branches and fixture drains within 10 pipe diameters downstream of a drainage stack due to what is termed hydraulic jump, a rise or wave of liquid waste in the horizontal pipe due to the vertical downward gravity flow in the stack as it hits the horizontal pipe. The subsequent rise of liquid waste blocks or restricts the airflow in the horizontal drain, thus pushing air downstream. This action can result in excessive pressures being exerted on fixture traps downstream of the stack. Connections to the horizontal drain must be far enough downstream of the stack where the hydraulic jump has dissipated. ●
