CHANGE SUMMARY: A new inspection has been established, applicable only to Type IV-A, IV-B and IV-C construction, that deals with connections where fire-resistance is provided by wood cover.

110.3.5

Type IV Connection Protection

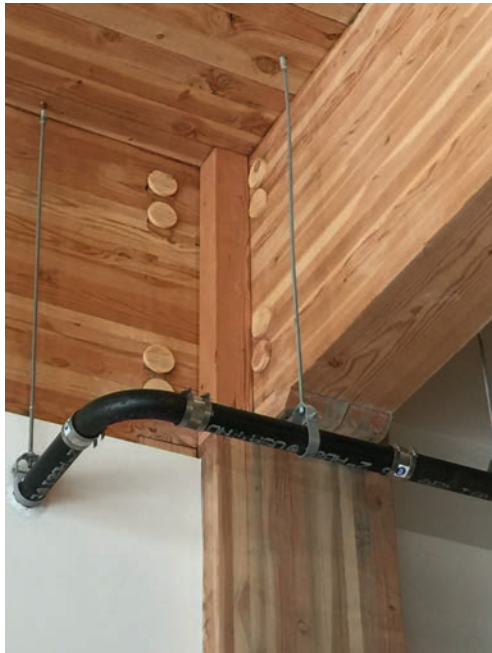
Wood cover protection of structural member connections to achieve a fire-resistance rating.

Connections of structural members, and their protection to achieve a fire-resistance rating, represent a significant component of mass timber buildings' structural integrity, and therefore warrant a specific new
