TECHNICAL REPORT

POLYPROPYLENE FIRE TESTING SYNOPSIS

NOVEMBER 9, 2020

VINYL
SIDING
INSTITUTE™

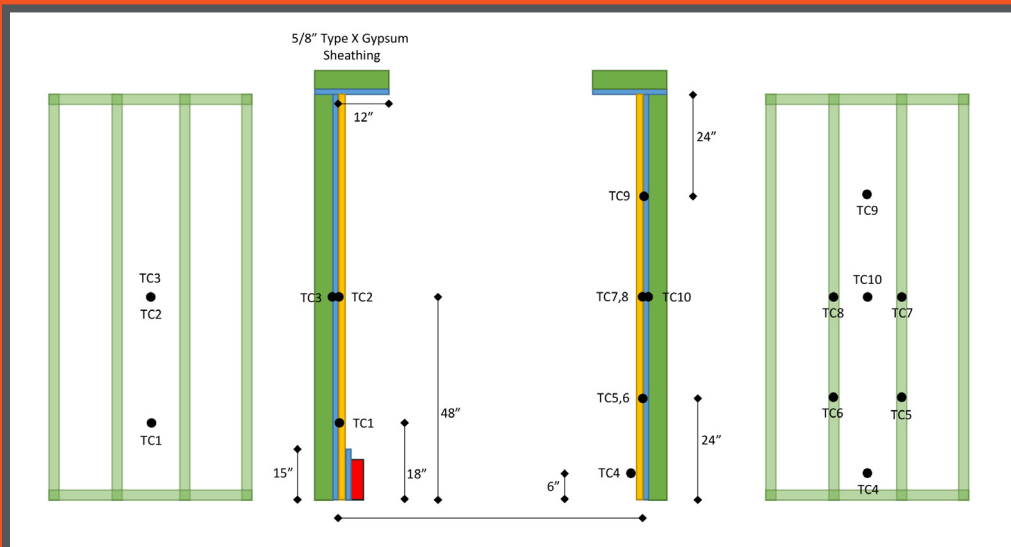
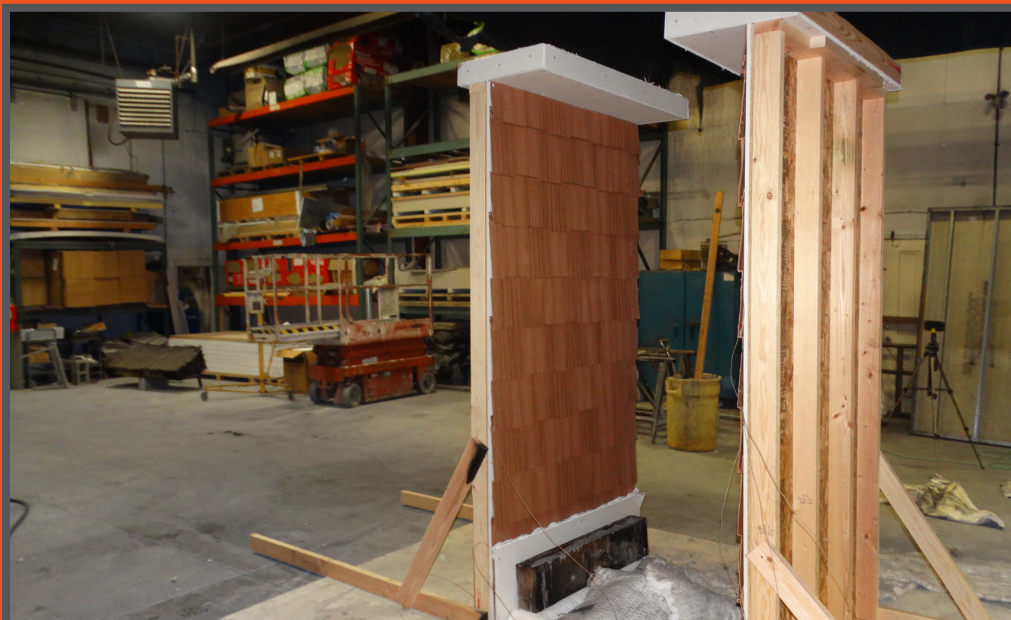
Photo of 4' burner wall

This test was conducted in the same setup manner as the 6' test, with the walls being spaced 4' apart. Both the burner wall and the receiver wall were comprised of wood framing, covered by OSB sheathing, covered by gypsum sheathing, and polypropylene siding.

TEST TIME (MM:SS)	EVENT
00:00	Start test – 150 kW burner on
00:30	Warping of siding on burner wall
01:00	Melted siding – exposed gypsum
01:30	Flames attached 5'
02:00	Spitting (about 12" – 18" from Burner Wall) material from siding
02:30	More intense fire
02:45	Buckling of siding on receiver wall
03:00	Most siding fallen/melted on burner wall
03:50	Drooping receiver wall siding
04:30	25% of receiver wall gypsum sheathing exposed
06:00	Small collection of fire at base of burner wall
07:15	Receiver wall siding mostly fallen – collected at base but not ignited
10:00	Burner off - collection of fire at burner wall only
20:00	Terminate test – no ignition of receiver wall – significant deformed/melted sections of polypropylene siding

The burner wall of a dual-wall system was exposed to a 150 kW burner for 10 minutes with an opposing receiver wall placed 4' directly opposed from the burner wall. Most of the polypropylene siding from the burner wall ignited and/or melted off the wall and continued to burn at the base of the wall. The receiver wall had significant deformation and melting of the polypropylene siding, exposing most of the gypsum sheathing behind it, but no ignition of the polypropylene siding.

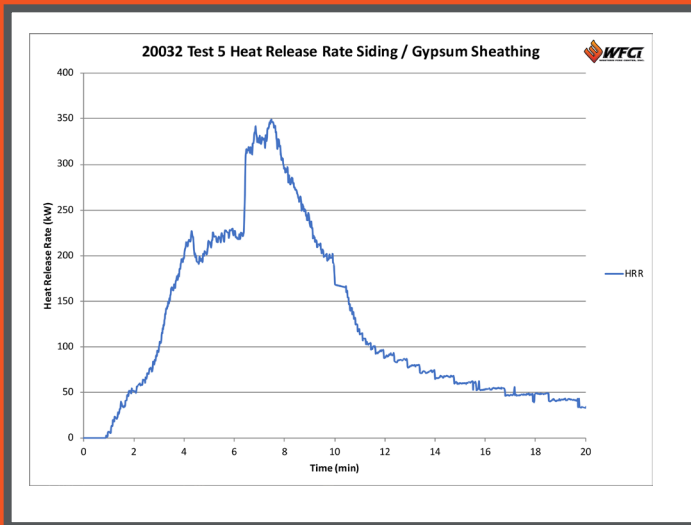
To the left is the heat release rate chart for Test 5.

The second baseline test consisted of a single wall that was built of an OSB base, gypsum sheathing, and polypropylene siding. All other aspects of the testing were similar to the first baseline test.

TEST TIME (MM:SS)	EVENT
00:00	Start test – 150 kW burner on
00:40	Warping of siding
00:55	Dripping material
01:10	Exposed gypsum
02:00	Flames approximately 6' up right side
03:00	Flames approximately 4' up left side
04:00	Increasing flames
04:45	Flames to soffit
07:20	Most wall engulfed
09:30	Reduced flames
10:00	Burner off - continued flames on wall and collect fire at base
20:00	Terminate test – slight flames on wall

The walls of two single-wall systems were exposed to a 150 kW burner for 10 min. Most of the polypropylene siding from the burner wall ignited and/or melted off the wall and continued to burn at the base of the wall. The OSB sheathing (Test 4) allowed for significantly faster and more intense flames (-4 min, peak —1100 kW) when compared to the gypsum sheathed (Test 5) assembly (-7min, peak 350 kW). The wall constructed with only OSB sheathing wall had burn-through of the sheathing prior to the burner shutting off. The gypsum sheathed wall did not have burn-through, and it also had a significantly lower heat release rate.
